SUN-ILLUMINATED SEA FLOOR TOPOGRAPHY OF QUADRANGLE 18 IN THE STELLWAGEN BANK NATIONAL MARINE SANCTUARY OFF BOSTON, MASSACHUSETTS

Page C. Valentine, Tanya S. Unger, and Jessica L. Baker

1999

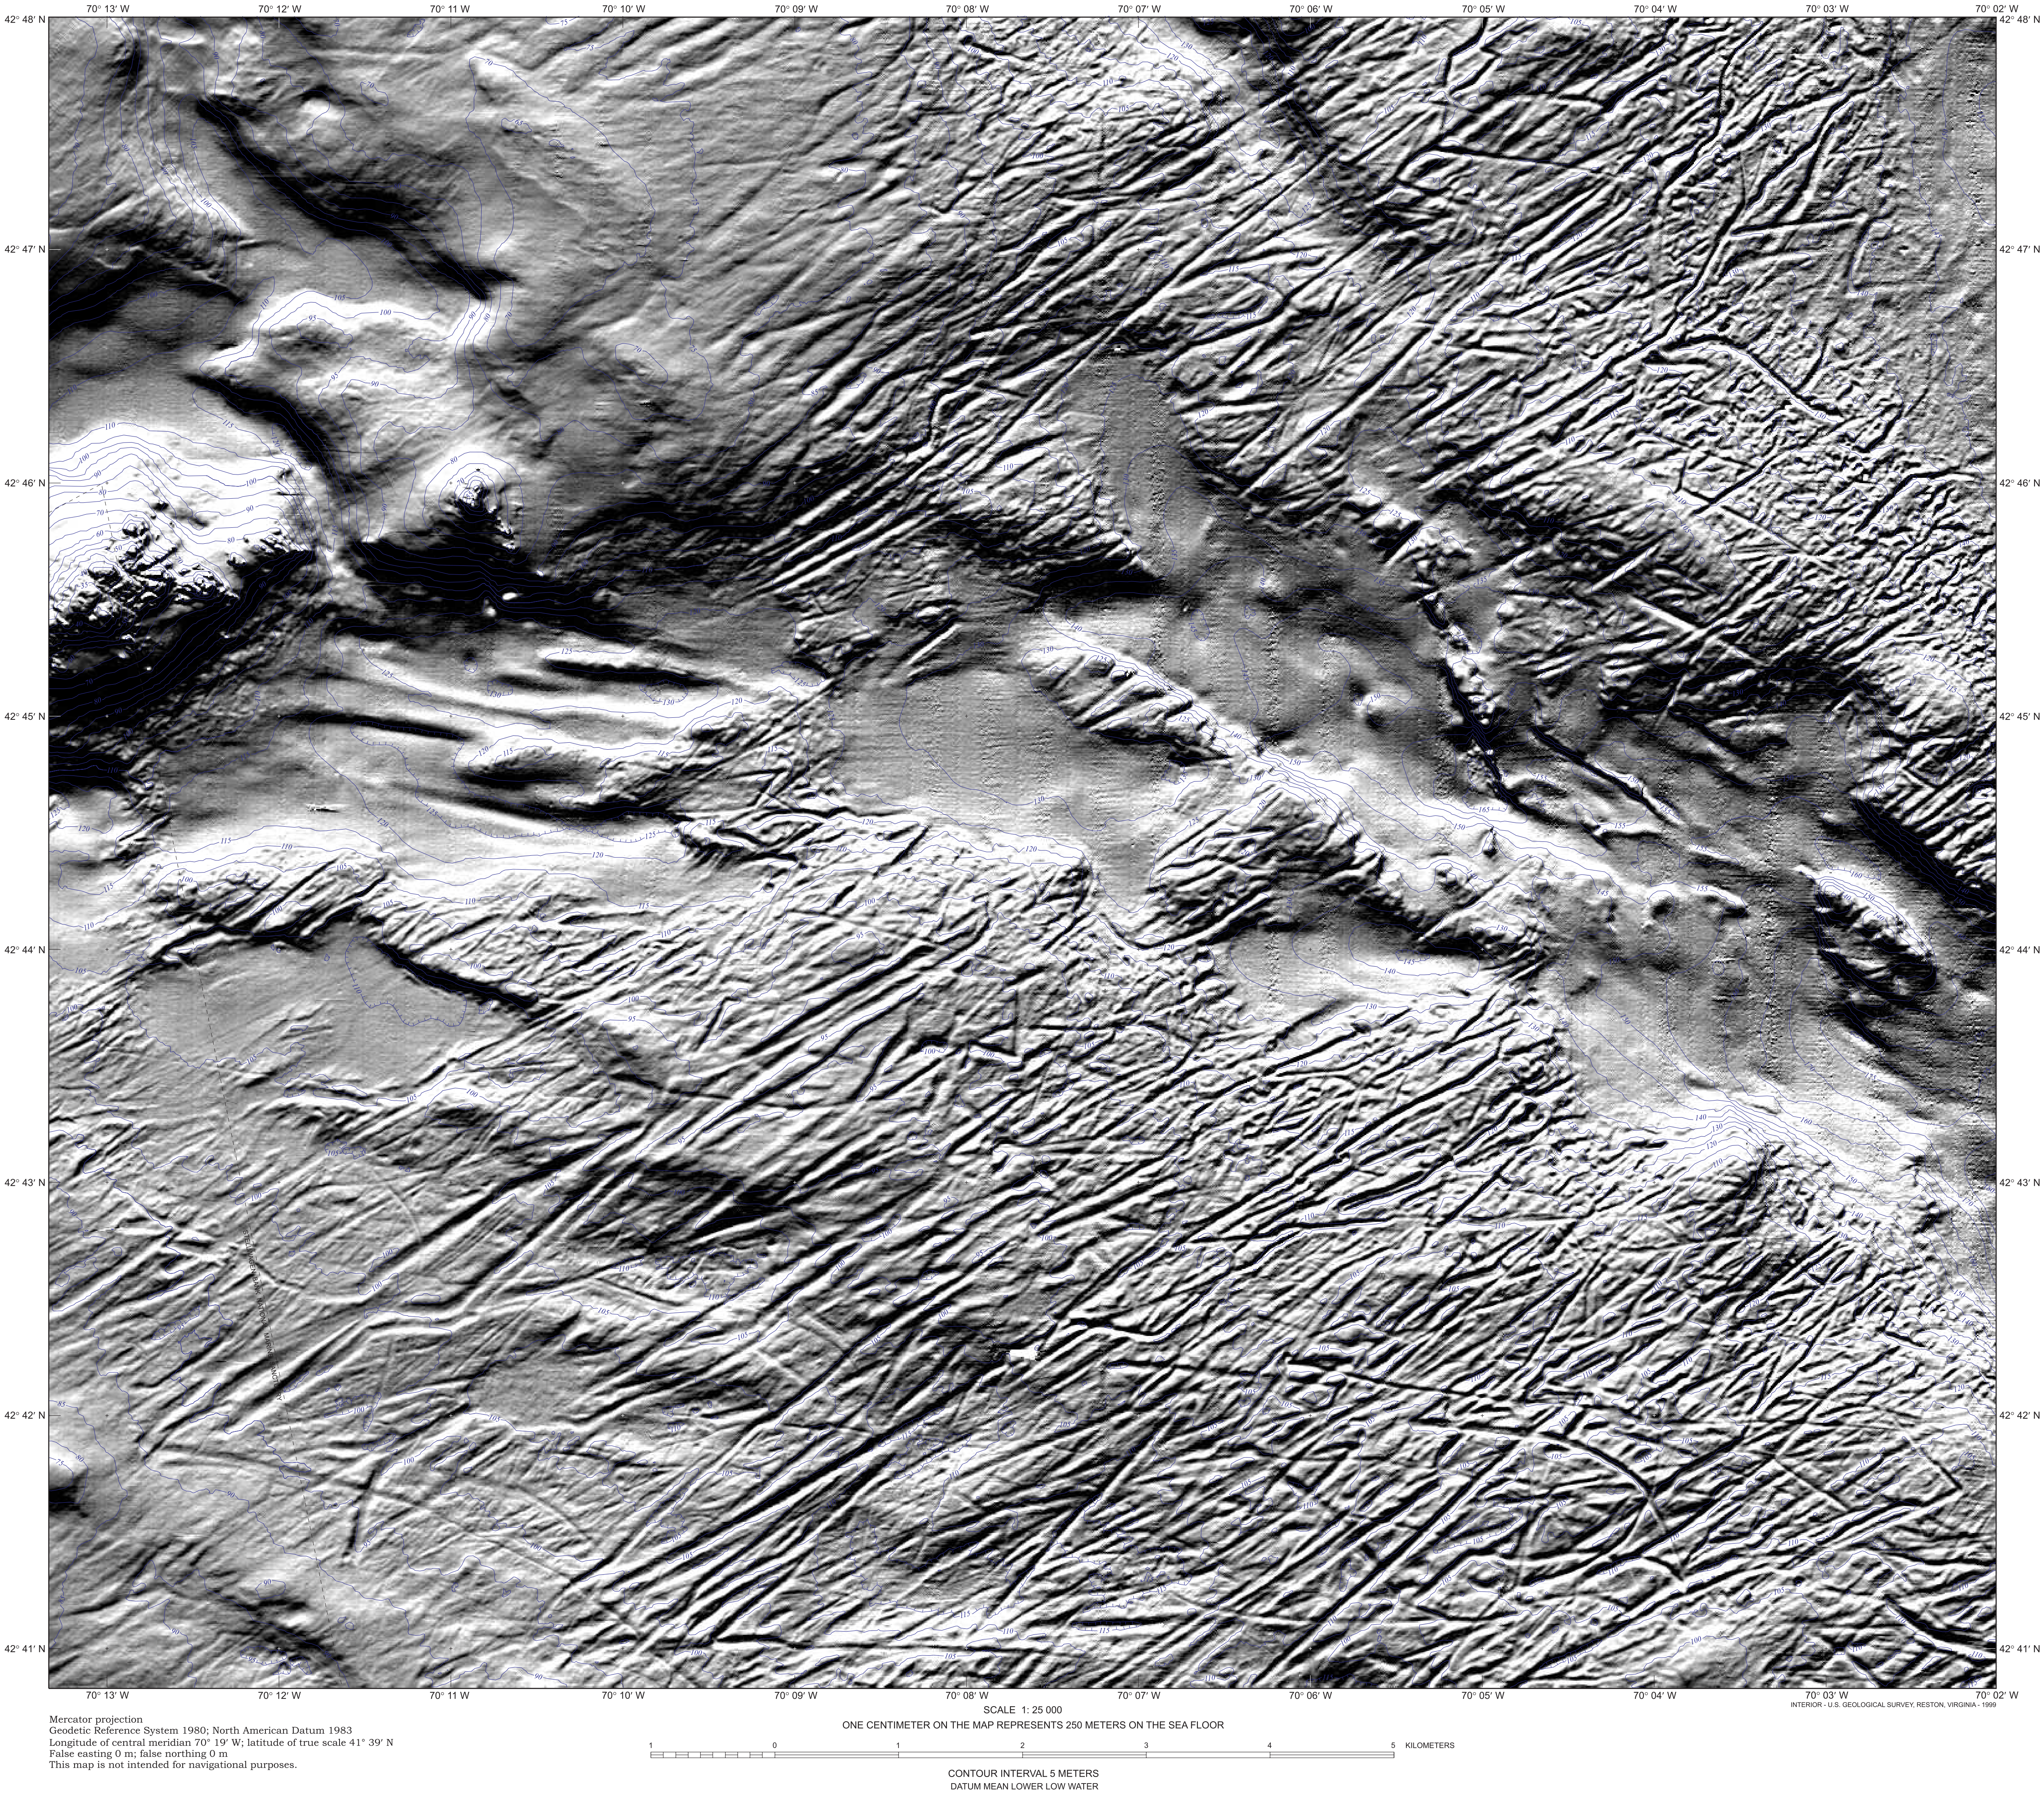
Quadrangle 18 features - In Quadrangle 18, the sea floor slopes regionally from approximately 85 m water depth in the southwest to 155 m in the northeast. Within this regional setting, the seabed is topographically variable and includes valleys, basins, hills, and a prominent hill that reaches a water depth of less than 35 m. The seabed in the southern and northeastern parts of the quadrangle exhibits a southeast-trending grain of small hills and basins that probably reflect the movement of a regional ice sheet. This is similar to the bottom type observed in the adjacent Quadrangle 15 to the south (Valentine and others, 1999a). These hills are low, rounded, typically have 5 to 10 m of relief, and are covered with gravel (including patches of boulders and cobbles) that is partly covered with a thin veneer

of sand. Between the hills, the seabed is chiefly sand with patches of gravel and scattered cobbles and boulders. A series of elongate, shallow, east- and southeast-trending basins is present in the central and eastern parts of the quadrangle. The basins deepen from west to east. They reach water depths of 110 to 175 m and their floors are 10 to 35 m below the surrounding seabed. The basin floors are relatively smooth and are covered with fine-grained sand and mud; the percentage of mud increases from west to east with increasing water depth. The most striking topographic features in Quadrangle 18 are many long, narrow grooves that dominate all but the northwestern part of the map area. They typically are 50 to 100 m wide, up to 5 to 10 m deep, and some are 5 kilometers long. These grooves are interpreted to be marks made by the jagged bottoms of icebergs that gouged the seabed by grounding here during the late stages of the last glaciation. The iceberg gouges are first observed at 145 m water depth in the northeast corner of the quadrangle, and they disappear in the 70- to 75- m depth interval in the shallow northwestern part of the map area. The floors of many of the deeper basins below 120 to 125 m are too deep to have been marked by the grounded icebergs. The iceberg grooves have a dominant northeast-southwest orientation. They become less distinct toward the northwestern and southwestern corners of the quadrangle. A large, conical hill is located along the western margin of the quadrangle (42° 45.5' N) that has a relief of 100 m (35 to 135 m) on its southwestern flank. This feature is an outcrop of resistant bedrock whose shape has been modified by the scouring of glacial ice. The ice apparently moved from west to east, removing material from the eastern (or lee) side of the peak and forming eastward-trending grooves and ridges (1 to 2 km long) in the adjacent basin. The flanks and base of the peak are covered with coarse sandy and gravelly sediments. A similar, but smaller, bedrock hill is located approximately 3 km to the northeast (42° 45.9' N, 70° 10.9' W) of the large hill. It reaches a water depth of 50 m and has a relief of 75 m (50 to 125 m) on its southern flank. These features are similar in character to two small hills on Jeffreys Ledge in the adjacent Quadrangle 17 to the west (Valentine and others,

1999b). North of the large hill, a sinuous basin floored with sand is bounded on the east and west by gravely seabed (patches of cobbles and boulders are common) that is partly covered by a thin veneer of sand.

Regional seabed features - The major topographic features depicted in the map series were formed by glacial processes. In broad terms, these features are interpreted here to represent a geologic history that developed in several stages. Ice containing rock debris moved across the region, sculpting its surface and depositing sediment to form the large basins, banks, ridges, and valleys. Many other features observed here represent the latter stages of deglaciation. They are the result of processes at work when much of the area was covered by stationary rotting ice, and when at the same time small valley glaciers and ice falls were active in and near areas of high topographic relief. The sea invaded the region formerly occupied by ice, and seabed features were partly eroded and some new sedimentary deposits were formed. Today, the sea floor mainly is modified by strong southwestward-flowing bottom currents caused by storm winds from the northeast. These currents erode sediments from the shallow banks and transport them into the basins. With time, the banks affected by these currents become coarser, as sand and mud are removed but gravel remains; and the western flanks of the banks, and adjacent basins, are built up by deposits of mud and sand.
